The Impact of Materials Science Analysis on an Alleged Electrical Causation

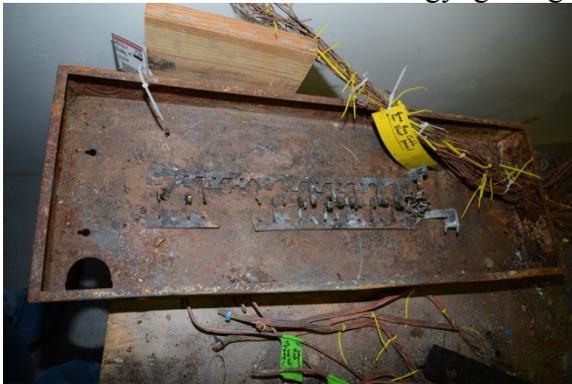
A fire incident occurred at a residence, and the alleged cause was identified as one of two Electrical Distribution Panels located in the garage of the structure. NEC's investigation into the cause of the fire incident did not commence until three (3) years subsequent to the date of the incident, and after multiple Site Inspections and Artifact Examinations had been performed by other investigators. The alleged cause of the fire incident was described as a defect within the subject Electrical Distribution Panel which resulted in an explosive nature that forced the cover off and the resultant thermal energy igniting nearby combustibles.

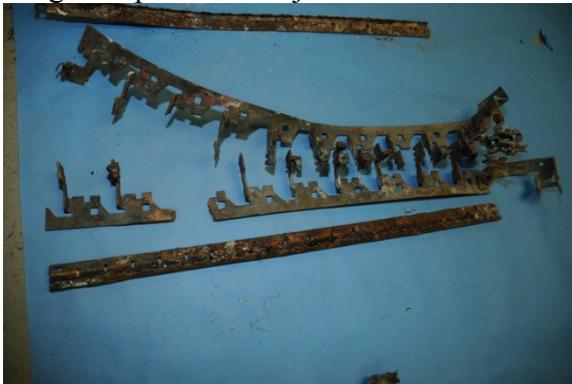
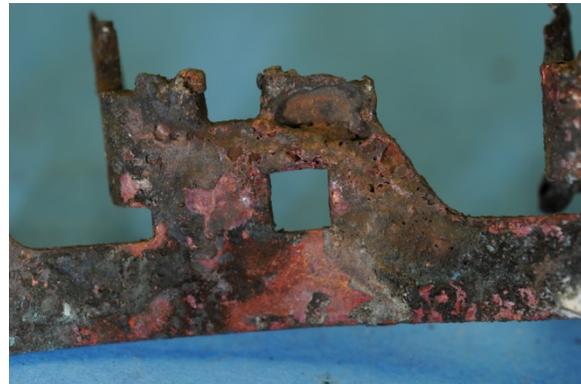
The two (2) Electrical Distribution Panels were similar in design and construction, and were positioned next to each other; however, the internal structure of the subject Electrical Distribution Panel was more heavily damaged than the adjacent panel subsequent to the fire incident. The alleged defect was an inadequate circuit breaker clip / bus bar stab connection. The bus bar was comprised of Copper based material and exhibited a melted portion of the bus bar in a specific location within the structure of the subject Electrical Distribution Panel. The alleged clip for the subject circuit breaker was not recovered.

The Plaintiff's experts alleged that the melt at the specific location of the bus bar was due to electrical fault activity at the circuit breaker clip / bus bar stab connection. One of the

Defendant's experts inclined to agree with the formation of the melt being attributed to electrical fault activity.

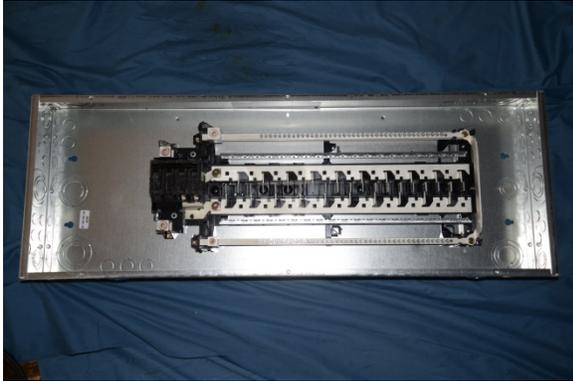
However, upon further examination of the subject Electrical Distribution Panel and an exemplar Electrical Distribution Panel, it was noted that the Neutral Bus Bar, which was comprised of Aluminum, was positioned in close proximity to the melted portion of the subject bus bar within the structure of the subject Electrical Distribution Panel.

In the present case, the subject Neutral Bus Bar had melted during the fire incident due to heat from an external fire. Materials Analysis, utilizing the techniques of Scanning Electron Microscopy and Energy Dispersive Spectroscopy (SEM/EDS), was performed on the melted portion of the subject bus bar from the subject Electrical Distribution Panel; and revealed Cu material in the melted sections as well as Al material. As such, the cause of the melt damage on the subject bus bar was attributed to alloying between Al and Cu, and not due to electrical fault activity.

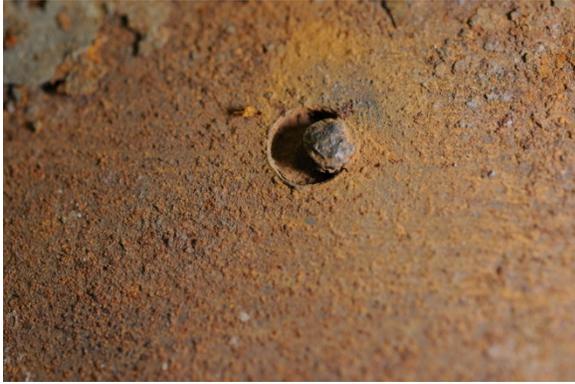
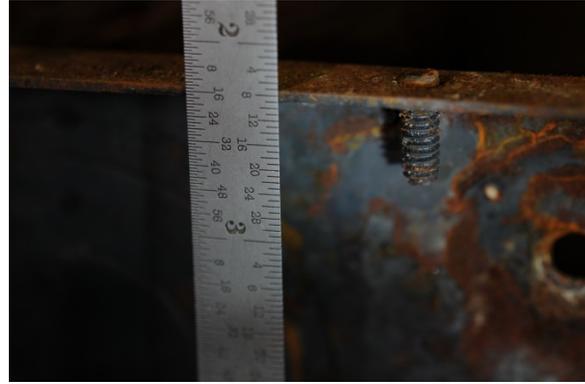
In addition, the mounting screws for the cover for the subject Electrical Distribution Panel did not exhibit mechanical fracture as would be anticipated had the cover been explosively blown off from an internal electrical fault event, as opined by the Plaintiff's experts. Further, the cover of the subject Electrical Distribution Panel exhibited openings due to electrical fault activity from an internal energized electrical cable as a result of an arcing through char process. The mounting screws for the cover of the subject Electrical Distribution Panel had actually melted off from high electrical current flow to ground from the main feed cable which had electrically faulted to the enclosure of the subject Electrical Distribution Panel during the fire incident. It had been established that the grounding connection at the site of the structure for the residence was improperly formed prior to the fire incident.

The discrepancy of the amount of interior damage between the subject Electrical Distribution Panel and the adjacent Electrical Distribution Panel was due to the cover of the subject Electrical Distribution Panel falling off early in the fire incident and exposing the internal components of the subject Electrical Distribution Panel directly to the heat from an external fire.
